PHASE IV REPORT

VOLUME II

RESULTS AND INTERPRETATION OF CHEMICAL GROUTING TEST PROGRAM

EXISTING LOCKS AND DAM NO. 26
MISSISSIPPI RIVER, ALTON, ILLINOIS

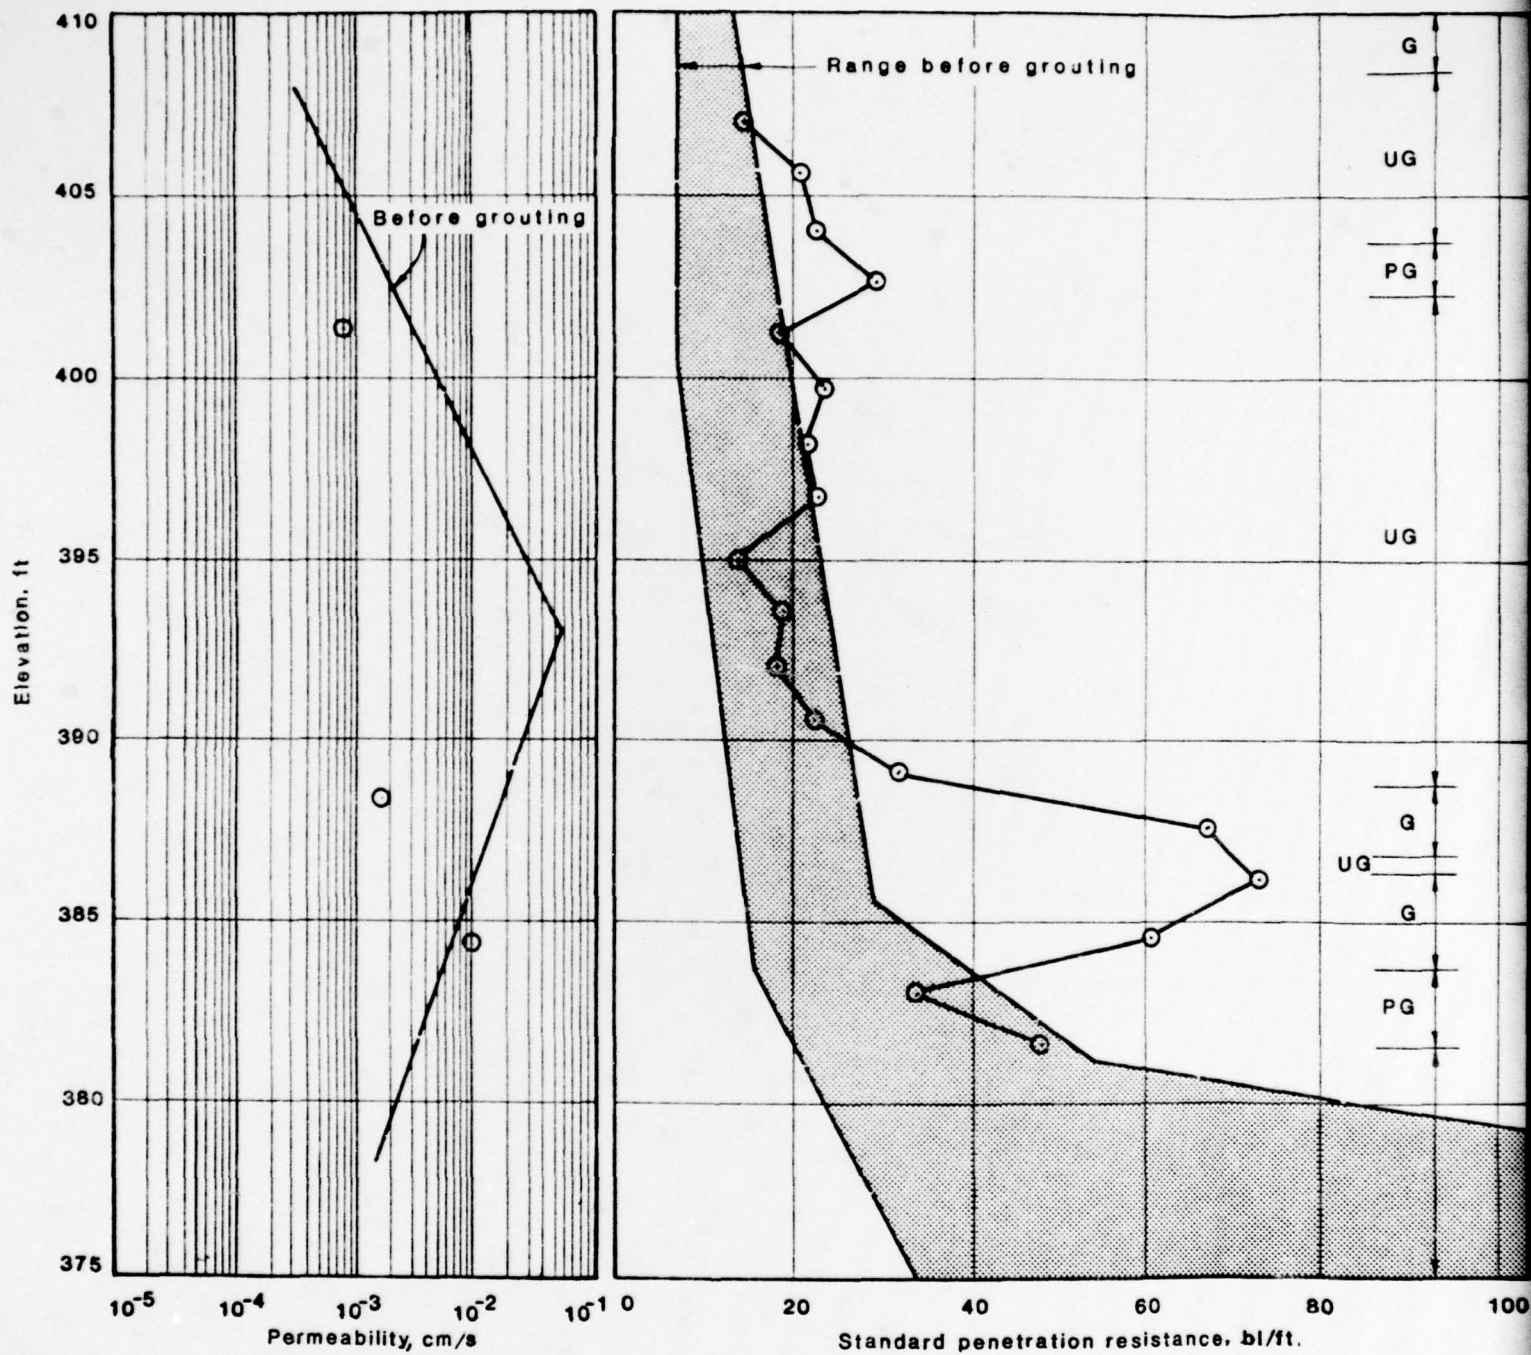
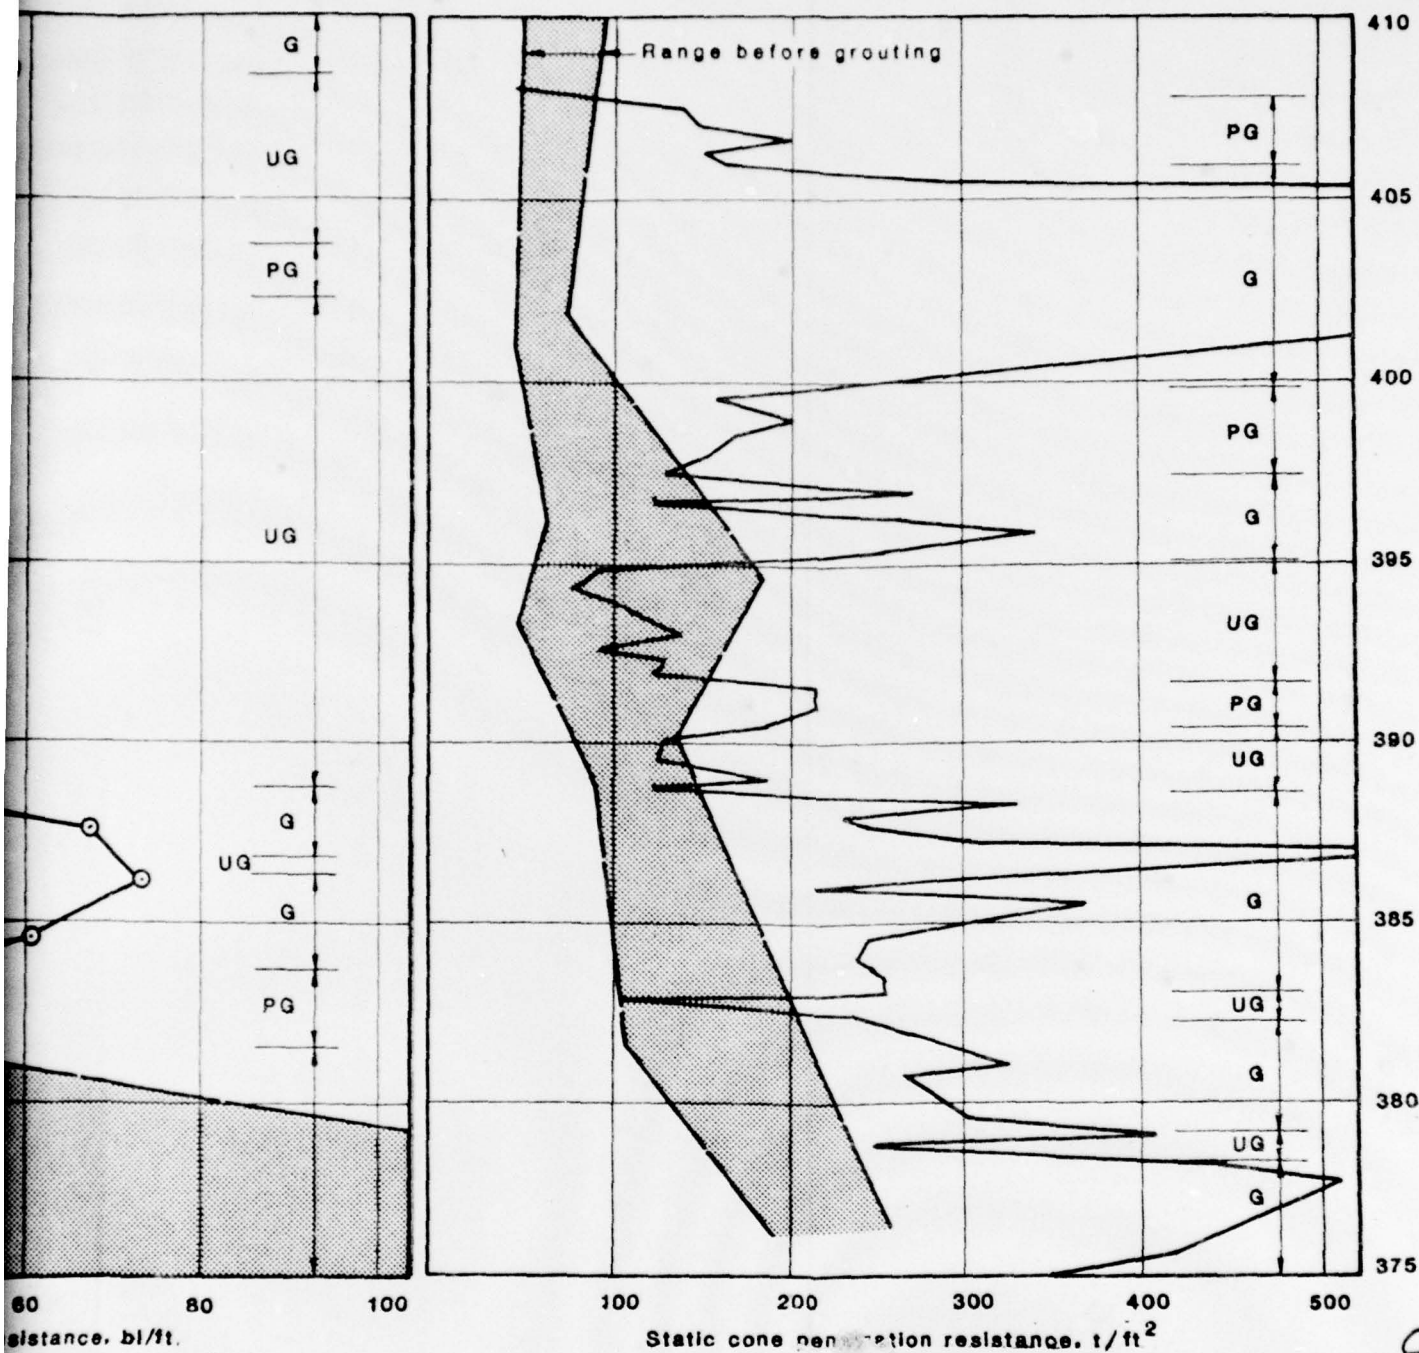
Woodward-Clyde Consultants YTC825 Phase IX	Fig. 9.3

UG: UngROUTed soil
 PG: Poorly grouted soil
 G: Grouted soil

RESULTS OF IN SITU TESTING
AFTER GROUTING SUBAREA 3

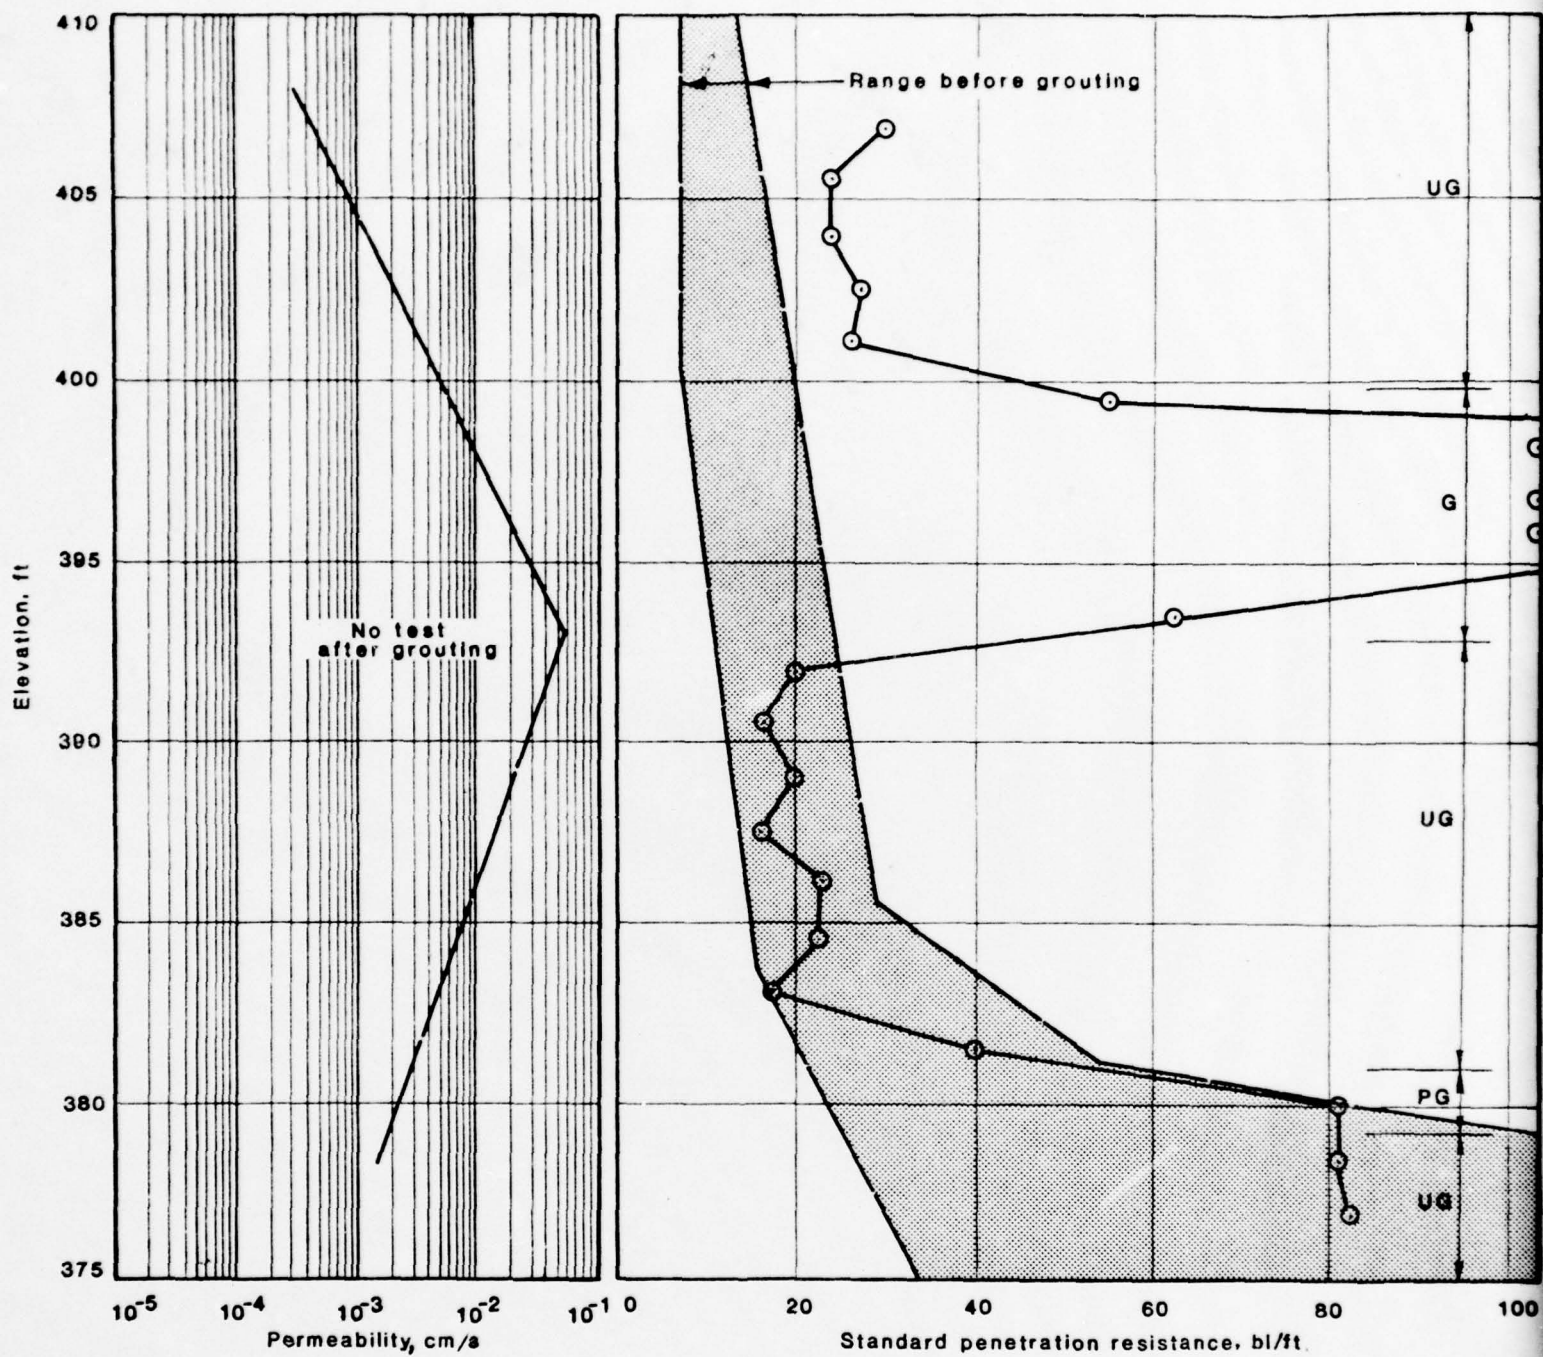
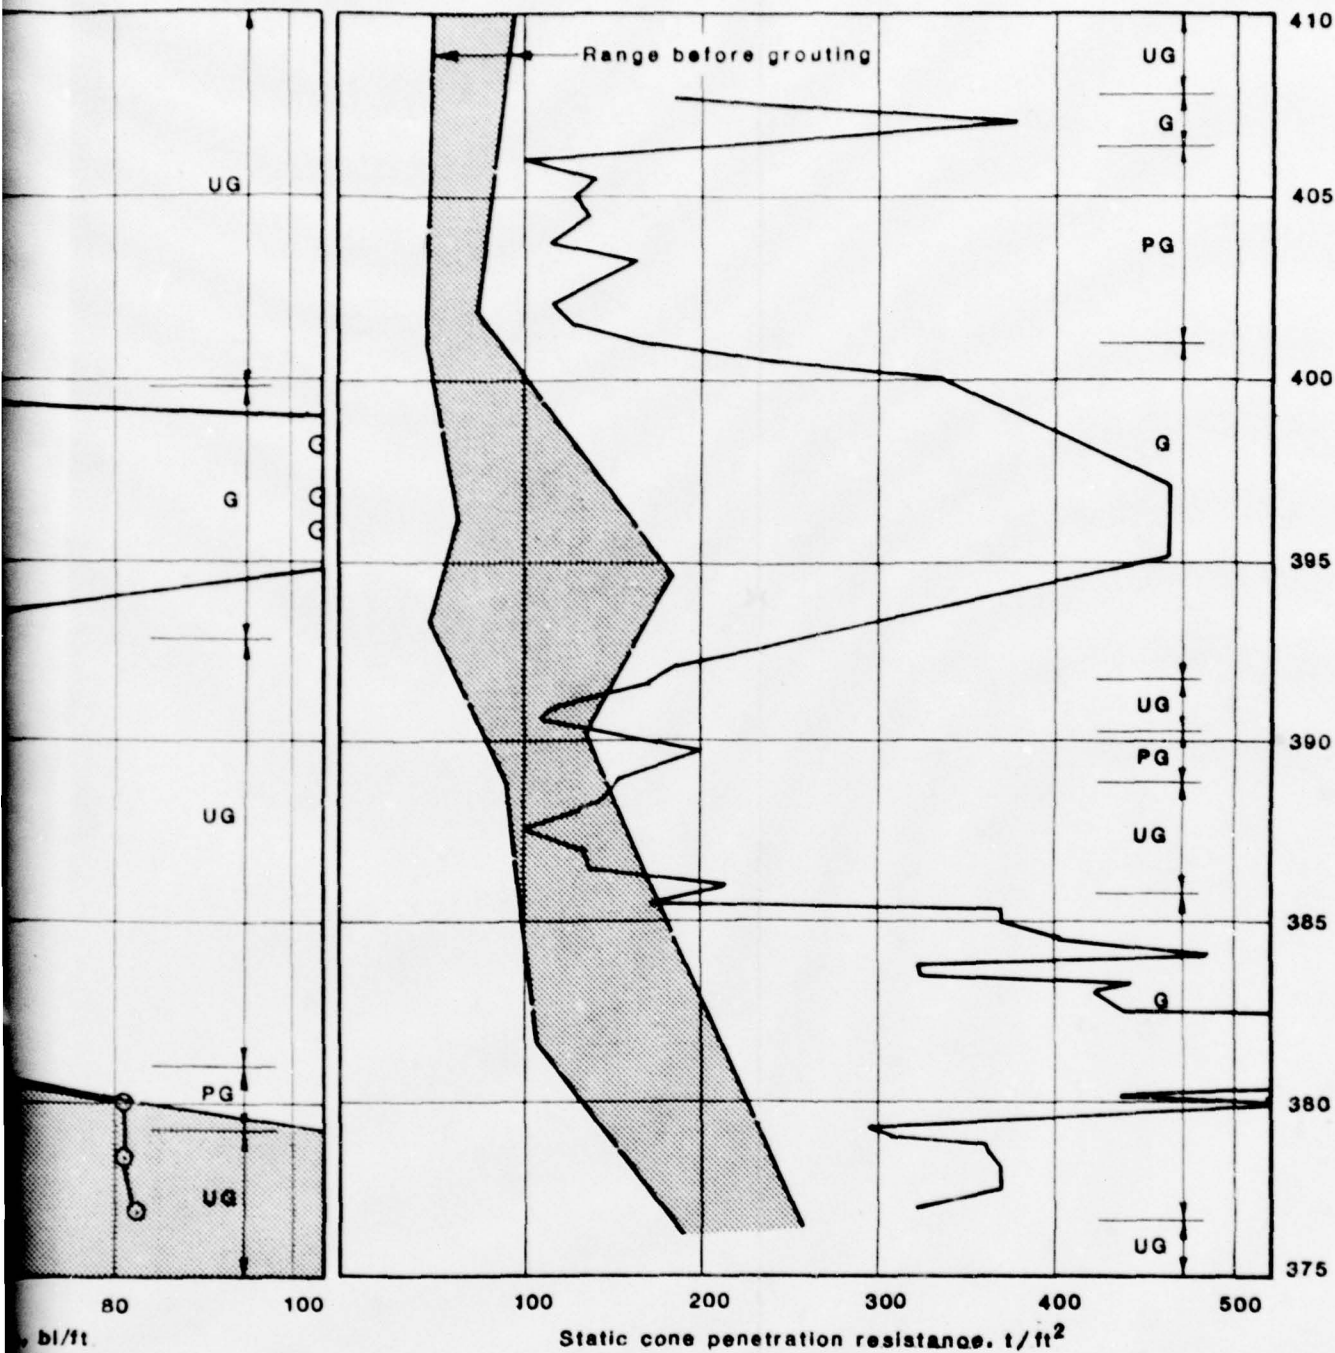
Fig. 9.10

RESULTS OF IN SITU TESTING
AFTER GROUTING SUBAREA 9

Static cone penetration resistance profiles from the fourteen AG-series borings performed after grouting are presented in Fig. 9.2 through Fig. 9.15. In

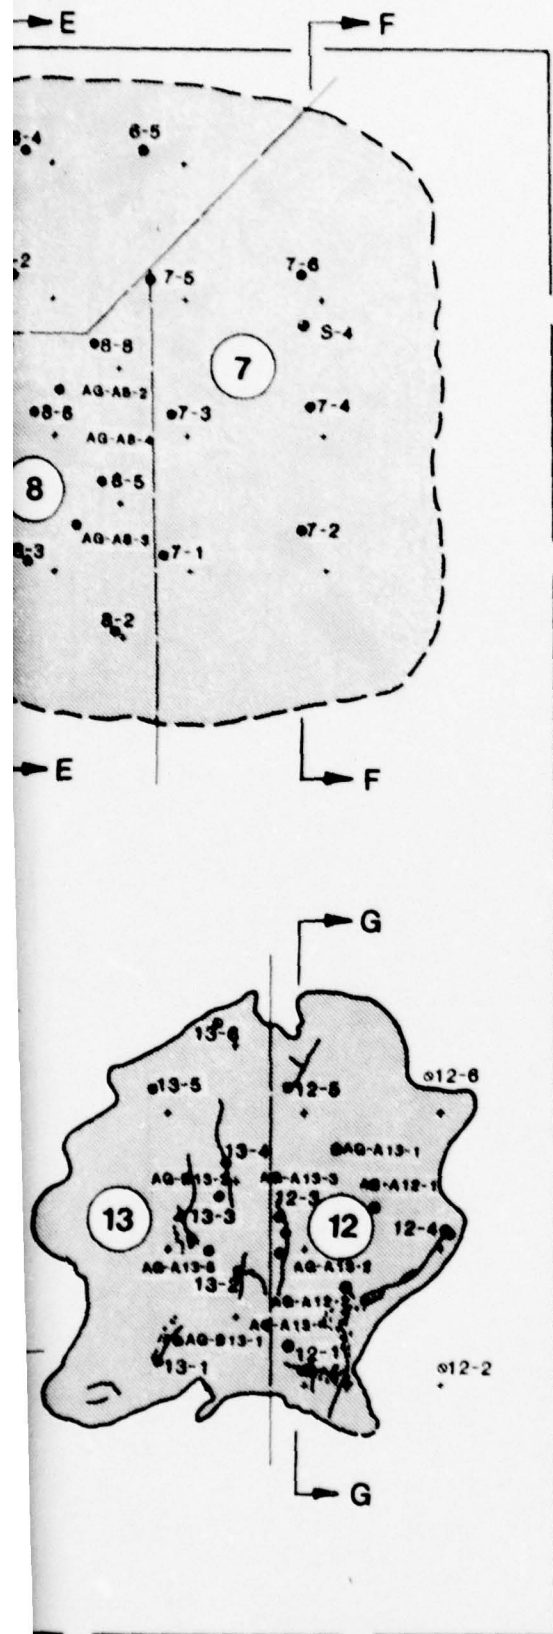
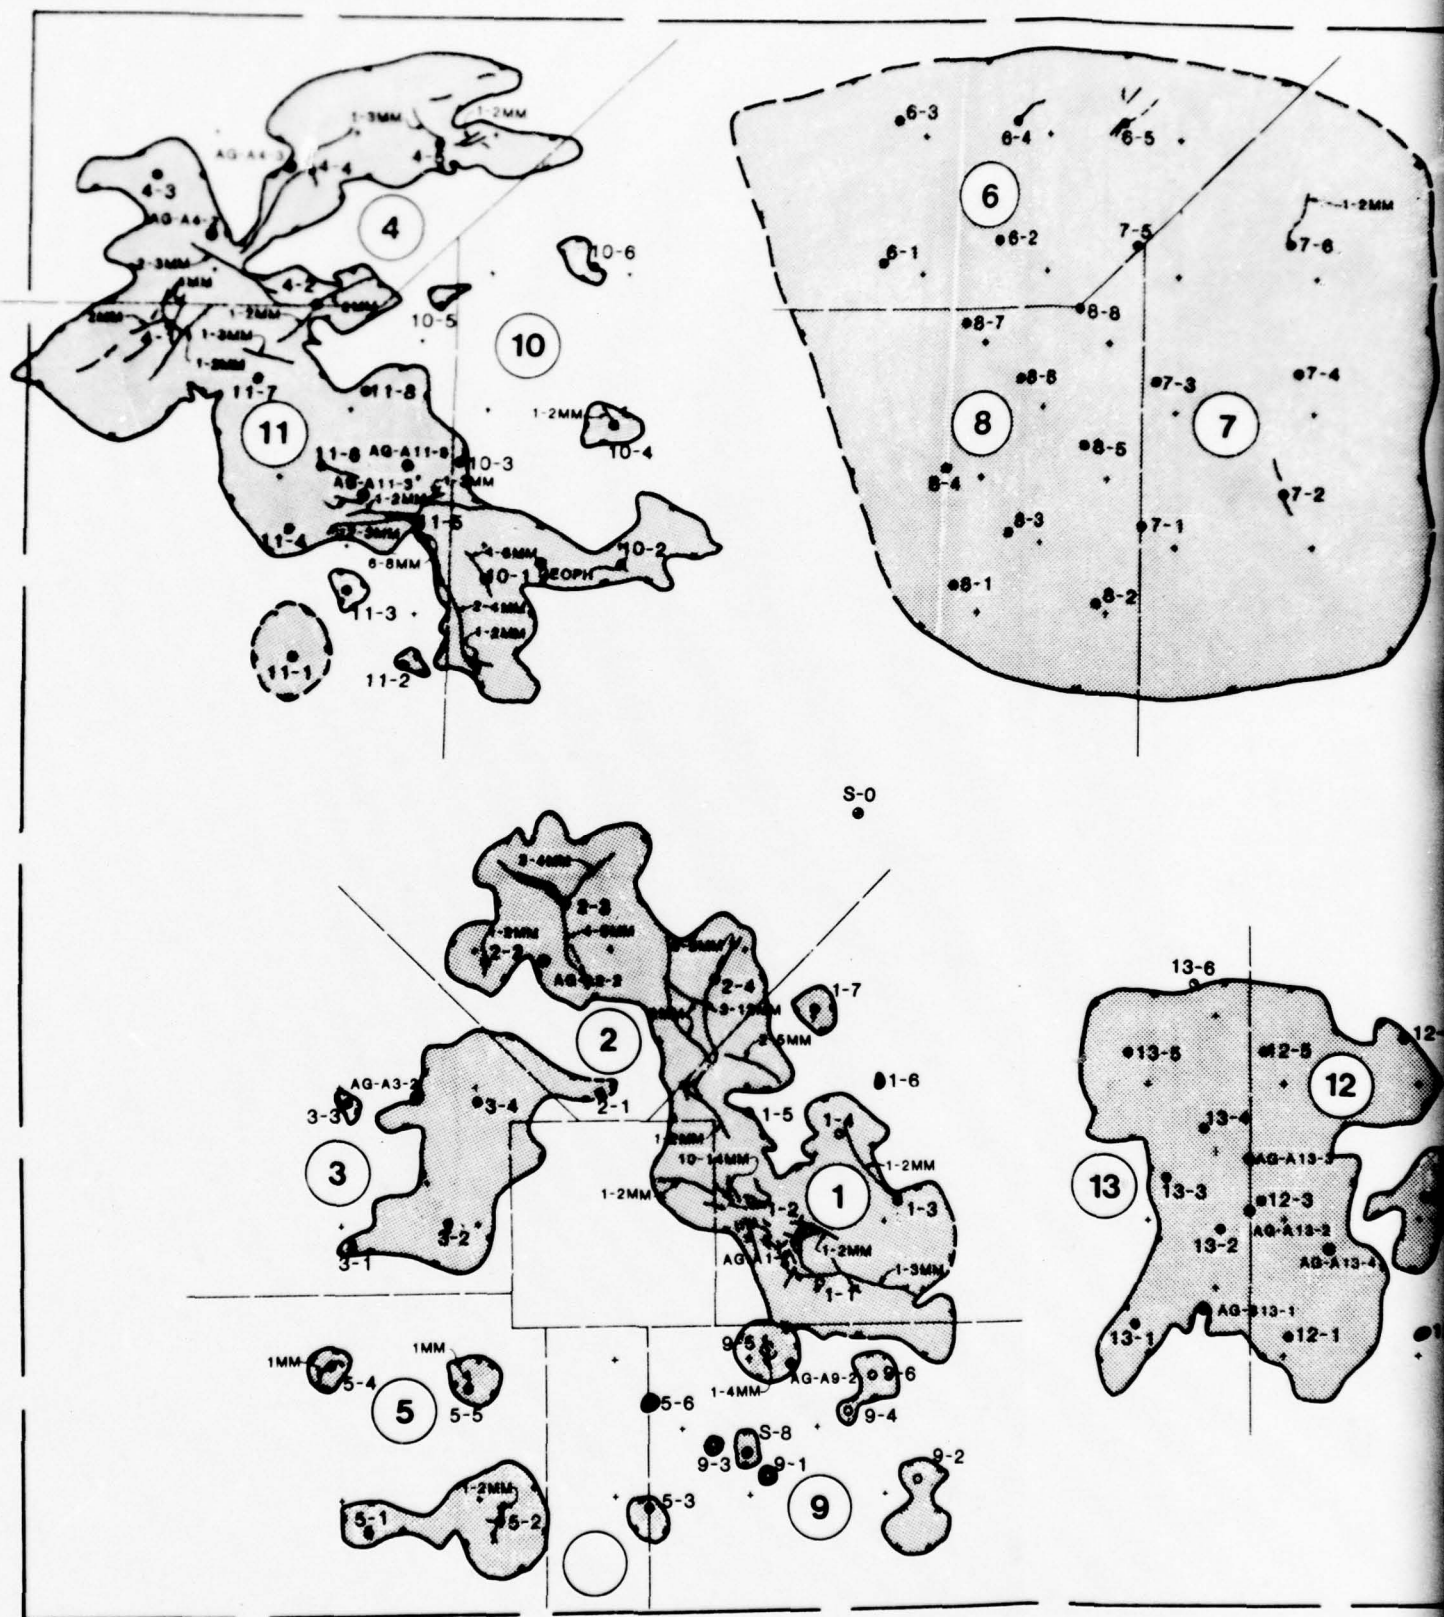
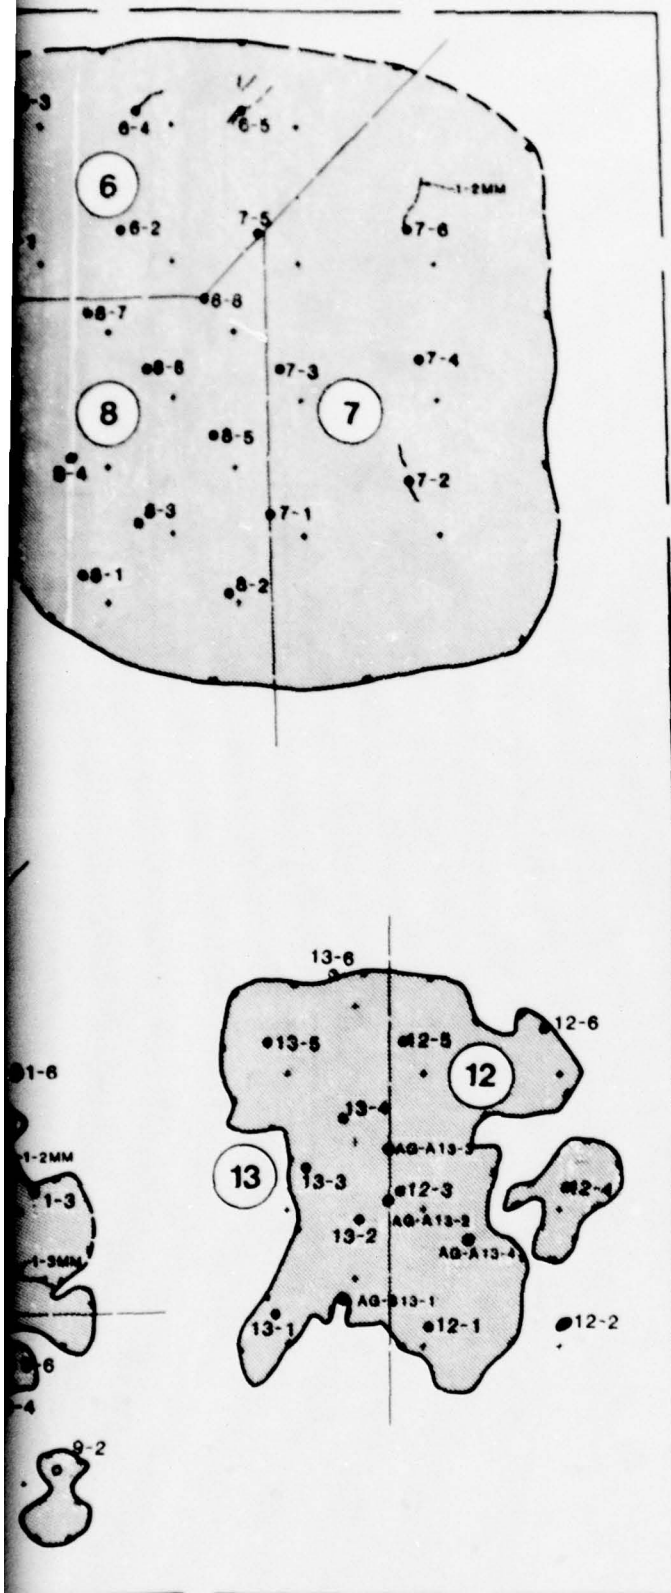
Fig. 9.17

- GROUT LIMITS (MAPPED)
- GROUT LIMITS (ESTIMATED)
- HYDRAULIC FRACTURES
(THICKNESS OF FRACTURE
IN MILLIMETER)
- CLAY
- WOOD, WOOD PARTICLES
- BORING
- SLEEVE PIPE
- GROUT PIPE NOT GROUTED
- OPEN-BOTTOM PIPE
- BENCHMARK
- LOCATION OF GROUT PIPES
AT GROUND SURFACE (EL 423)
- TEST SUBAREA
- GROUT PAD LIMITS
- TEST SUBAREA LIMITS

Influence of Carbonaceous Materials on Grout Distribution. Carbonaceous materials (wood, lignite, charcoal) were abundant and widely distributed throughout the grouted soil in the test area. Wood was only found between el 400 and el 393. Some of these materials significantly influenced grout penetration and consistency of grouted soil. Concentrations of wood fragments, charcoal and lignite pebbles were often found to be only partly grouted or less firmly grouted than surrounding soils free of carbonaceous inclusions. Large wood pieces, such as buried tree branches and tree trunks sometimes controlled grout distribution. These materials, being far more compressible than the surrounding sand in which they were buried, were probably compressed under the grout pressure. They acted as conduits for the grout, enabling the grout to flow far from the injection point. Examples of this phenomenon occurred in Subarea 9 between el 394 and el 398 (Fig. 9.16) and between Subareas 11 and 3 at approximately el 394 (Fig. 9.17).

The elevation of the horizontal sections shown in Fig. 9.16 through 9.19 are indicated in Fig. 9.30. These sections are reproduced in Fig. 9.31 through 9.34 together with the location of the geophysical borehole arrays. From these figures, it can be seen in a simplified manner that the shear wave velocities were not only influenced by the type of grout, but also, and probably more significantly, by the extent of grout penetration. Subareas 7 and 8, and 12 and 13 were massively grouted. Subareas 10 and 11 were not entirely grouted. Subareas 1 and 9 were poorly grouted. UngROUTED zones significantly reduced shear wave velocities, because these measurements reflect the bulk properties of the mass through which the waves propagate.

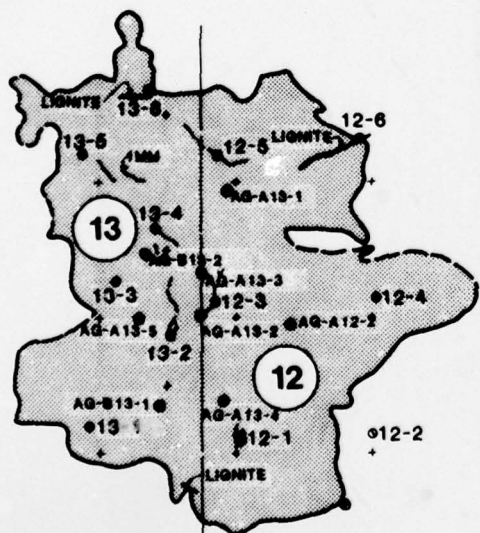
CHEMICAL GROUTING TEST PROGRAM
HORIZONTAL SECTION
THROUGH TEST AREA
AT EL 385

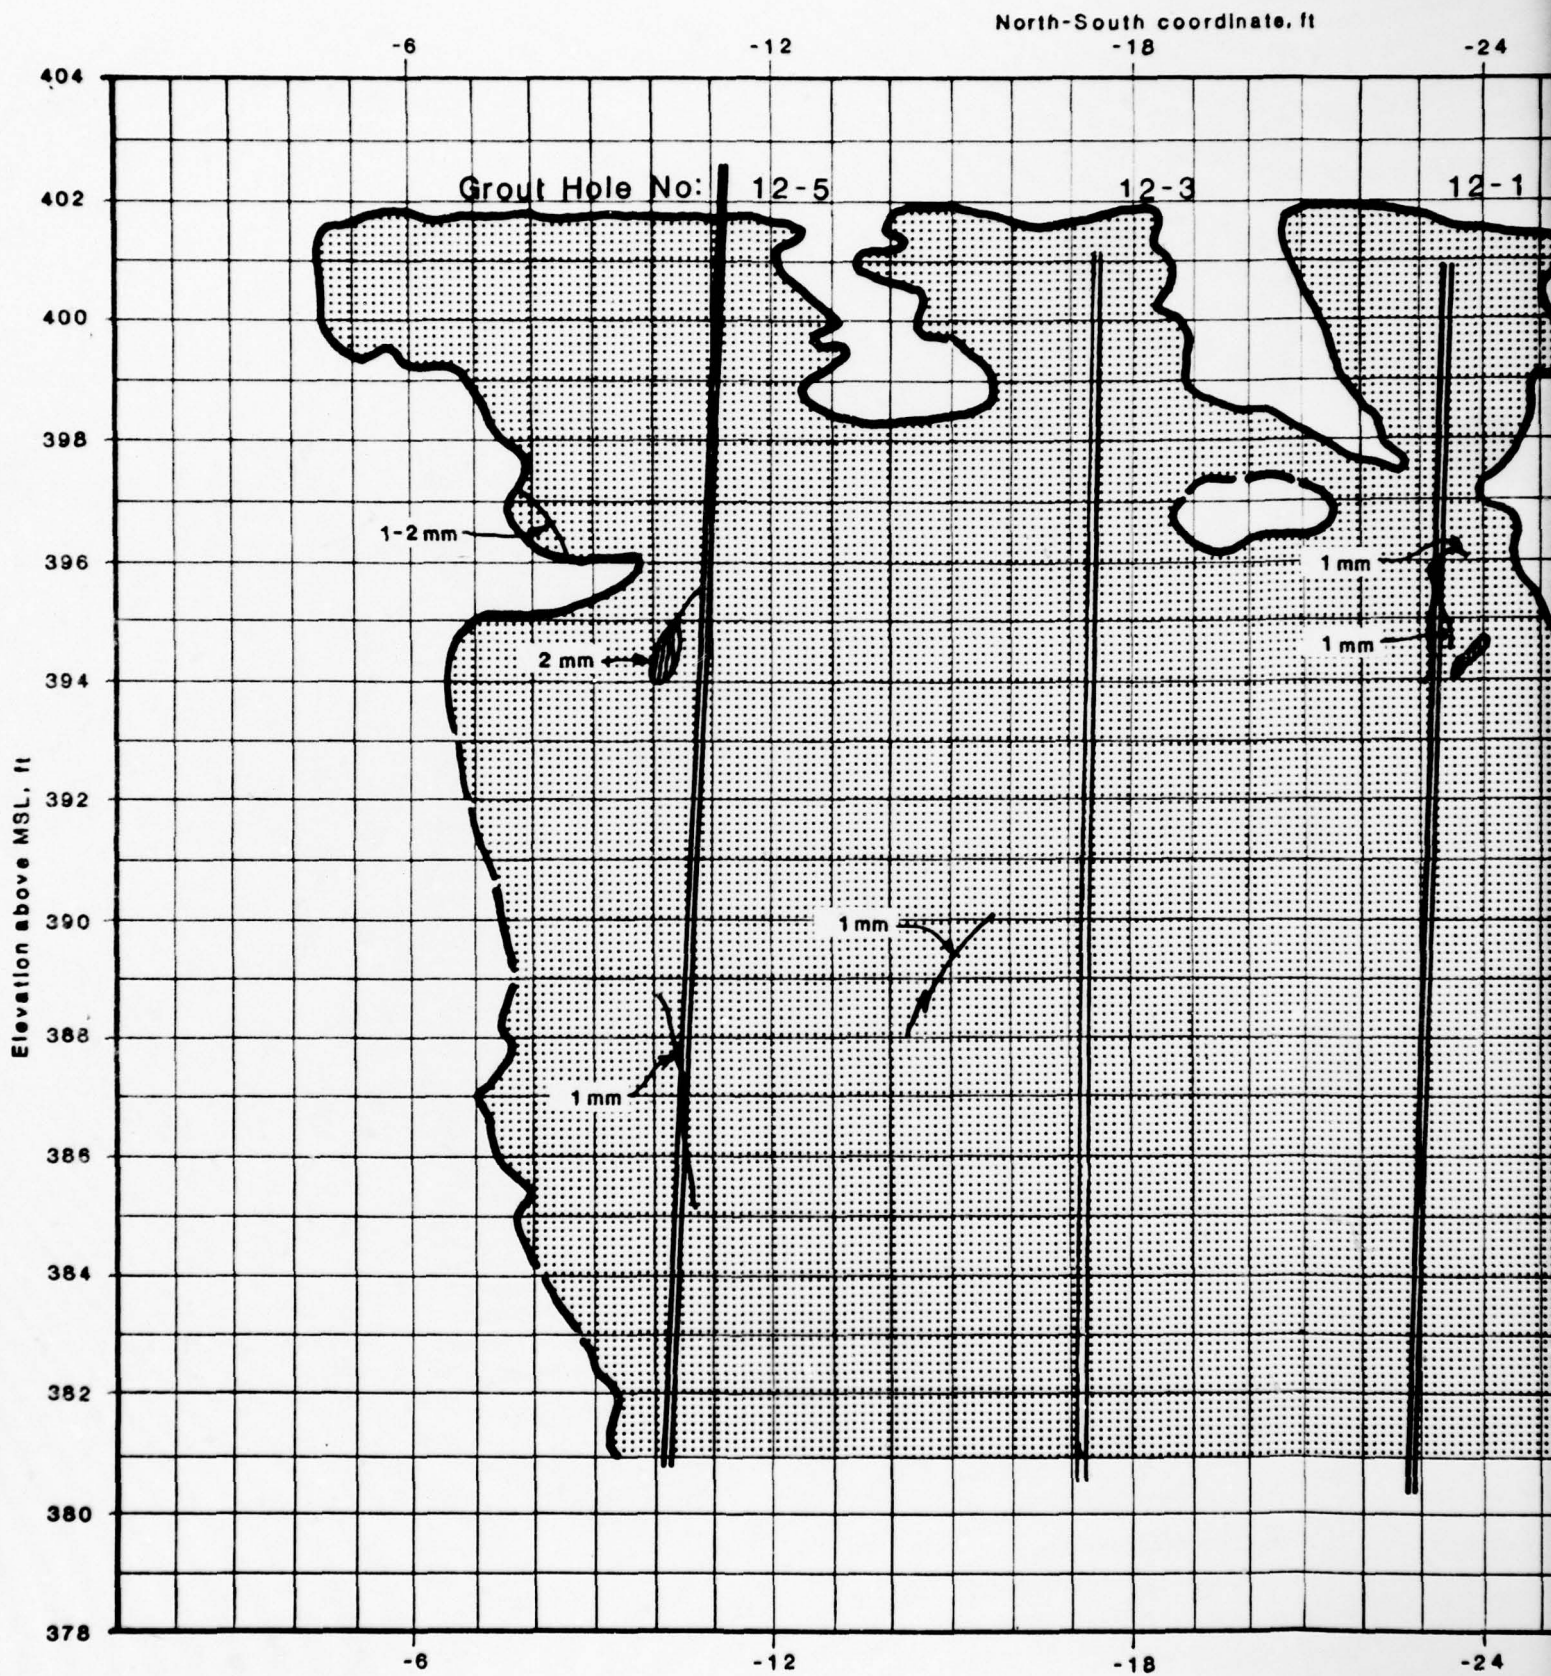
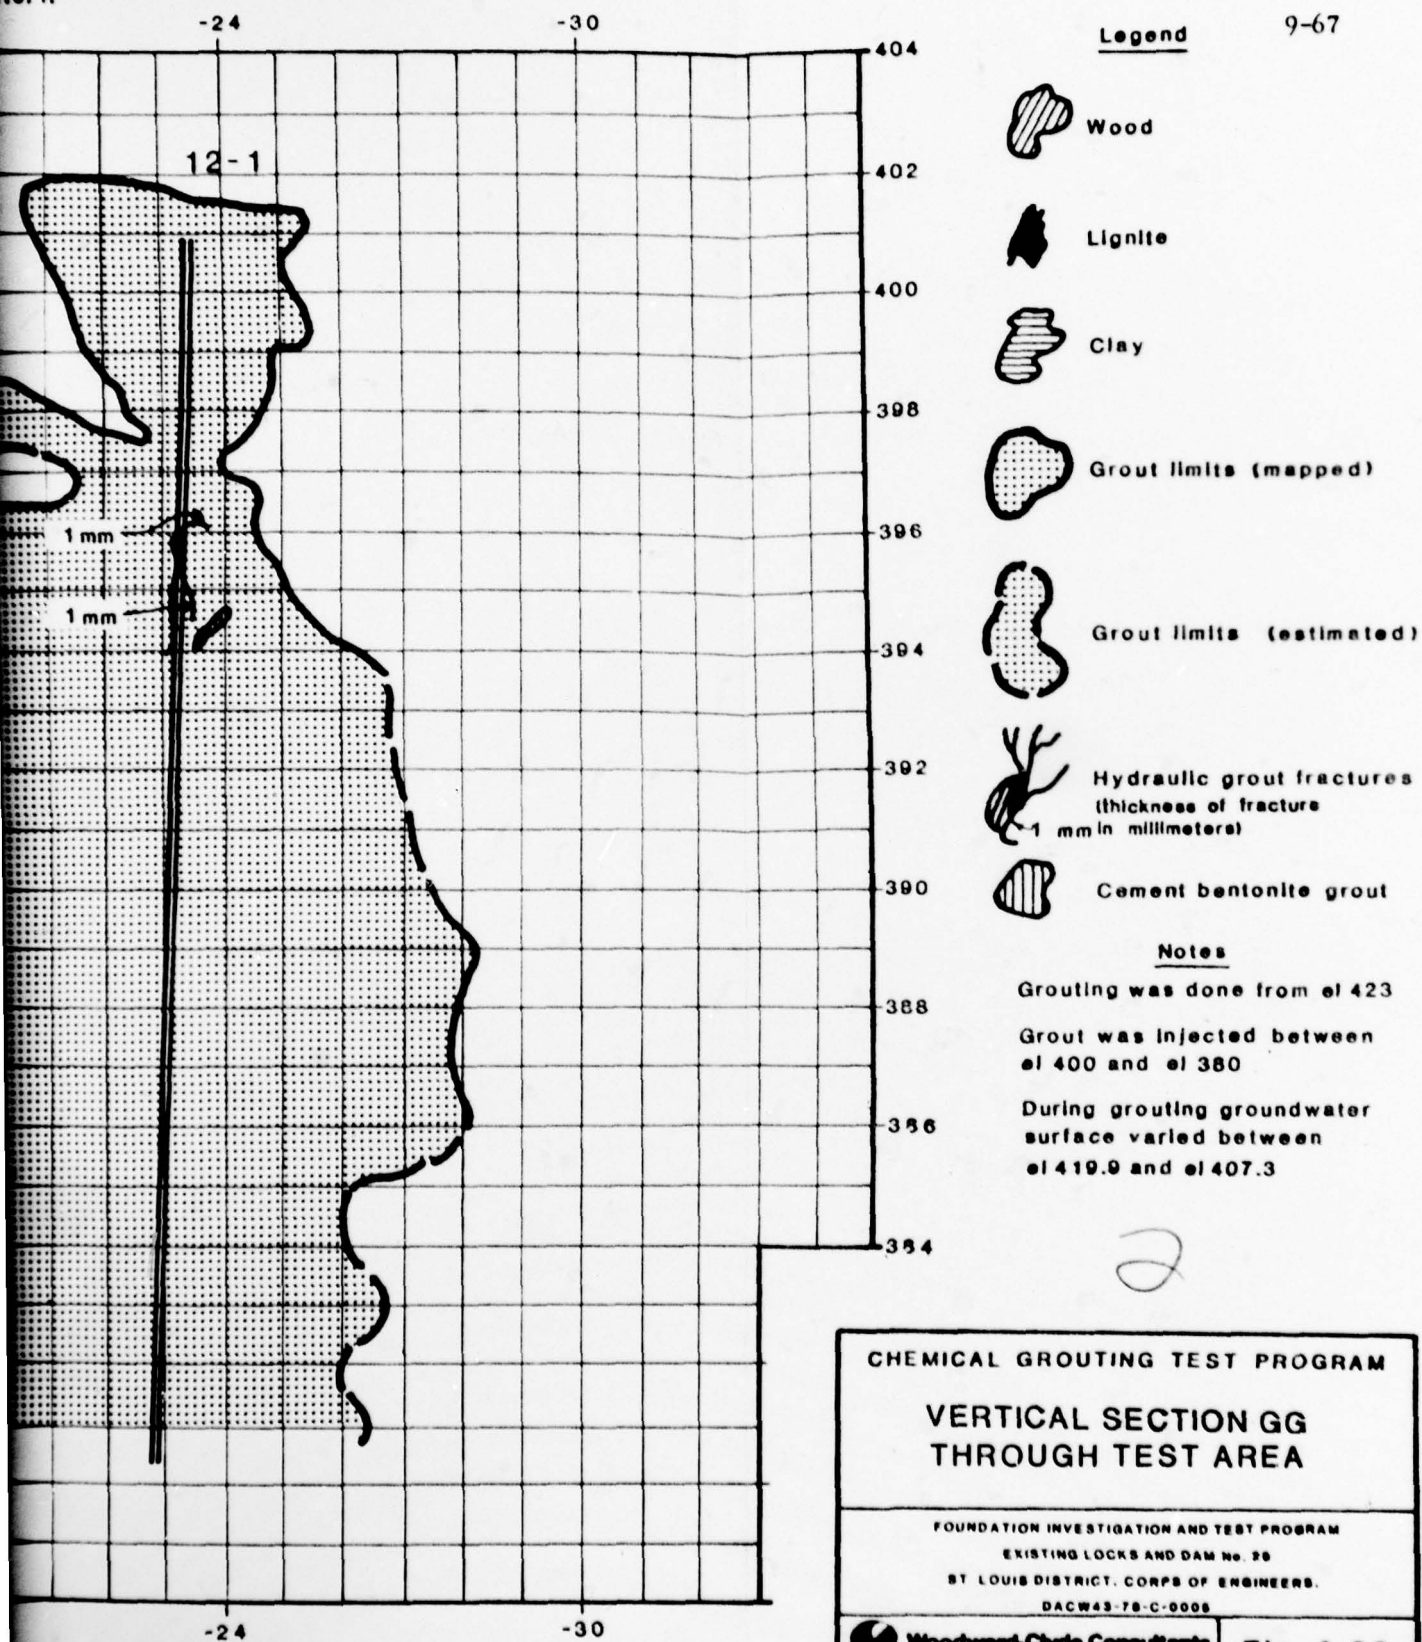
Fig. 9.25

VERTICAL SECTION GG
THROUGH TEST AREAFOUNDATION INVESTIGATION AND TEST PROGRAM
EXISTING LOCKS AND DAM No. 26ST LOUIS DISTRICT, CORPS OF ENGINEERS.
DACW43-78-C-0005

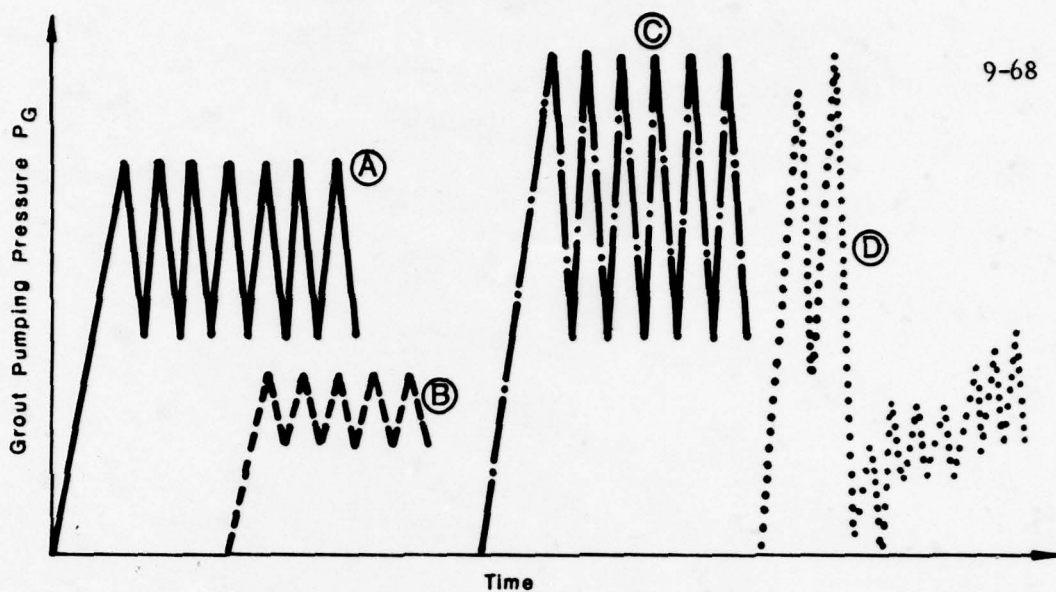
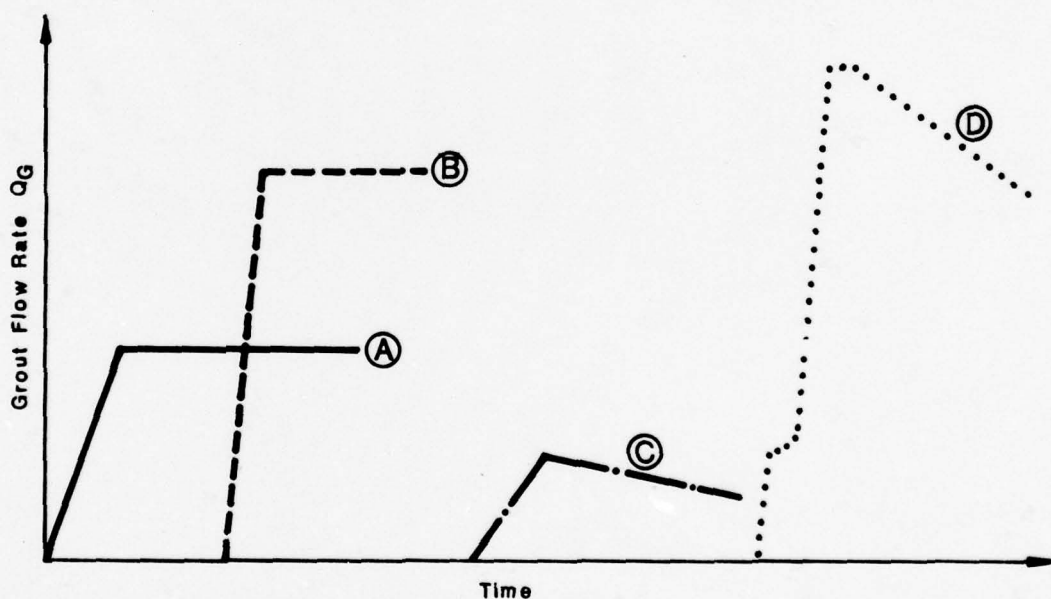
Fig. 9.26

- (A) Good grout penetration in fine to medium sand
- (B) Good grout penetration in medium to coarse sand
- (C) Difficult grout penetration in fine or already grouted sand
- (D) Hydraulic fracturing

CHEMICAL GROUTING TEST PROGRAM
IDEALIZED GROUT PUMPING
PRESSURE AND RATE RECORDS
FOR ALLUVIAL GROUTING

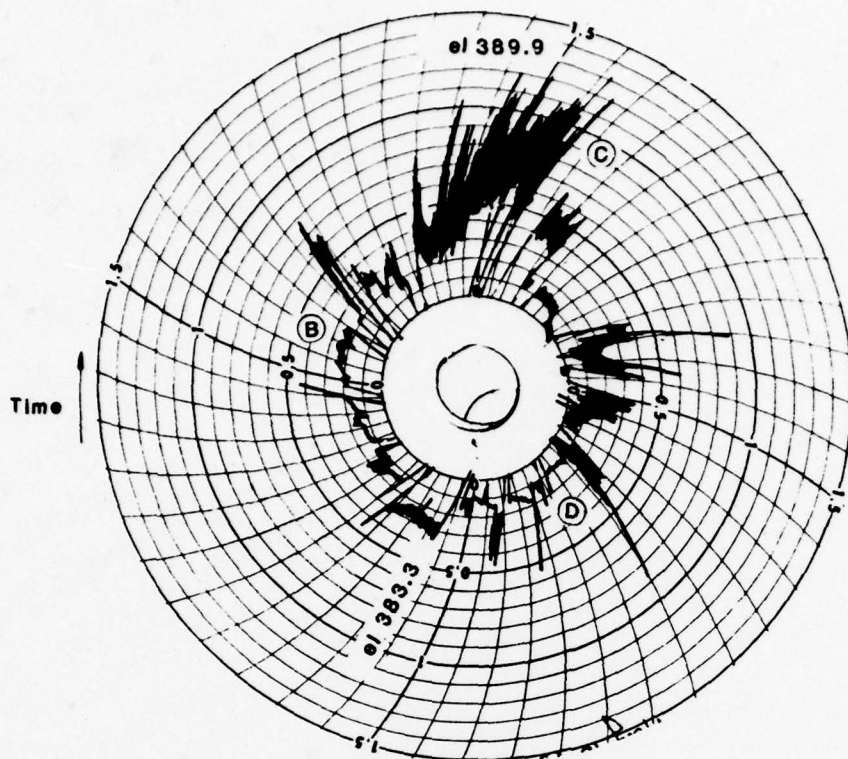
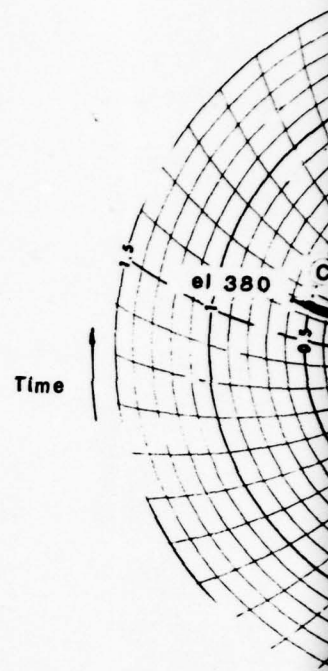
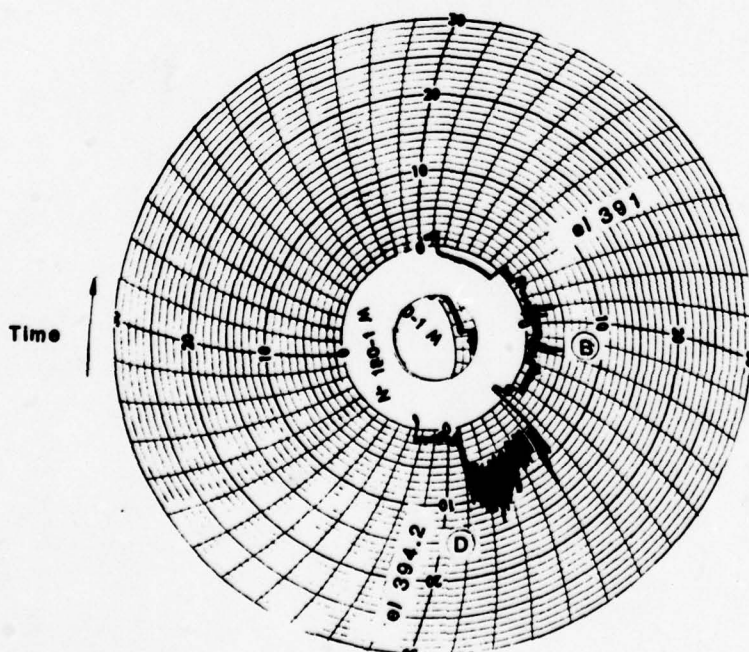
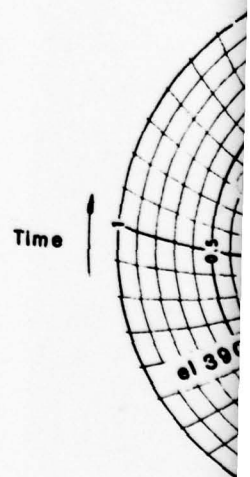
Fig. 9.27

(a) 1st Stage grouting-Grout Hole 8-4
(el 383.3 to el 388.6)

(b) 4th S

(c) 1st Stage grouting-Grout Hole 11-8
(el 391 to el 394.2)

(d) 1st S

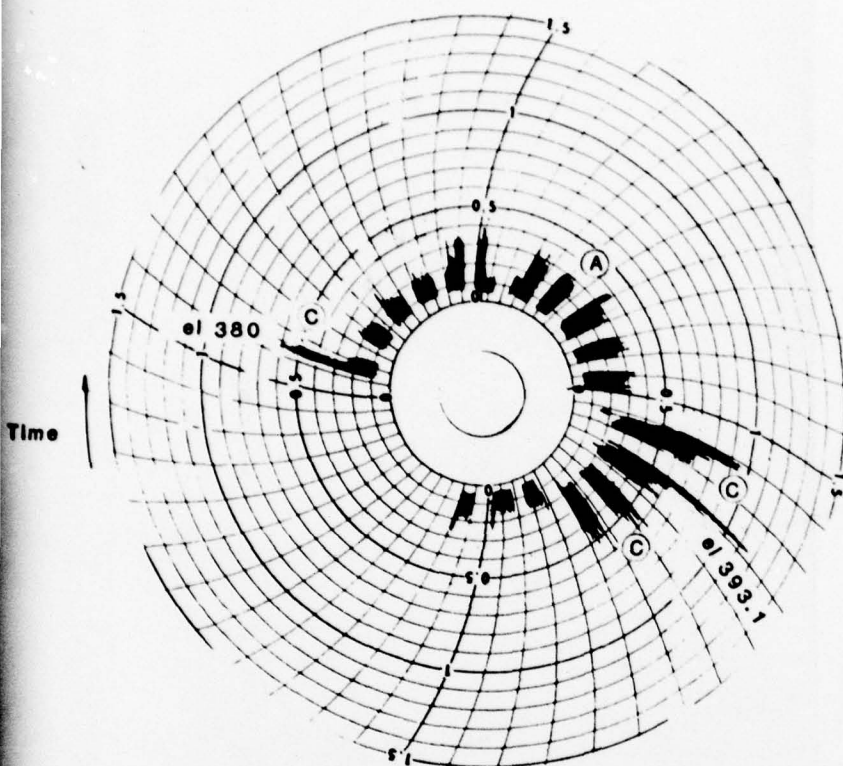
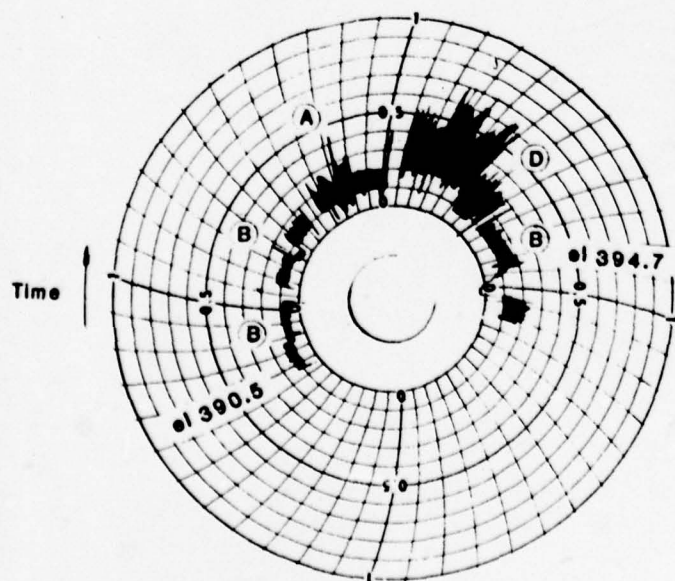
(b) 4th Stage grouting-Grout Hole 12-1
(el 380 to el 400)

- (A) Good grout penetration in fine to medium sand
- (B) Good grout penetration in medium to coarse sand
- (C) Difficult grout penetration in fine or already grouted sand
- (D) Hydraulic fracturing

(d) 1st Stage grouting-Grout Hole 12-1
(el 390.5 to el 394.7)

CHEMICAL GROUTING TEST PROGRAM
EXAMPLES AND INTERPRETATION
OF ACTUAL GROUT
PUMPING PRESSURE RECORDS
